Devil's Slide/Hwy 1 Storm Repair

Daily Updates from Bijan Sartipi

Daily Update
June 7

Devil's Slide (post mile 39.14)

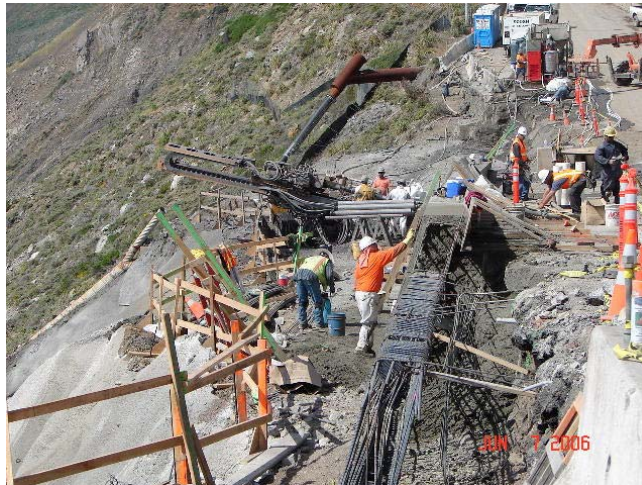
- Whaler wall construction above and below the road:
Whaler wall 'A' below the road – rebar installation and concrete work taking place simultaneously on different sections.

Whaler wall 'A' construction.

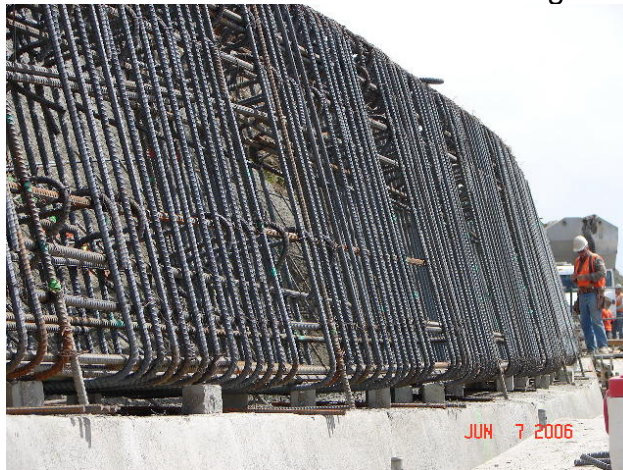
Whaler wall 'D' above the road – installing formed rebar continues.

Rebar for whaler wall 'D'

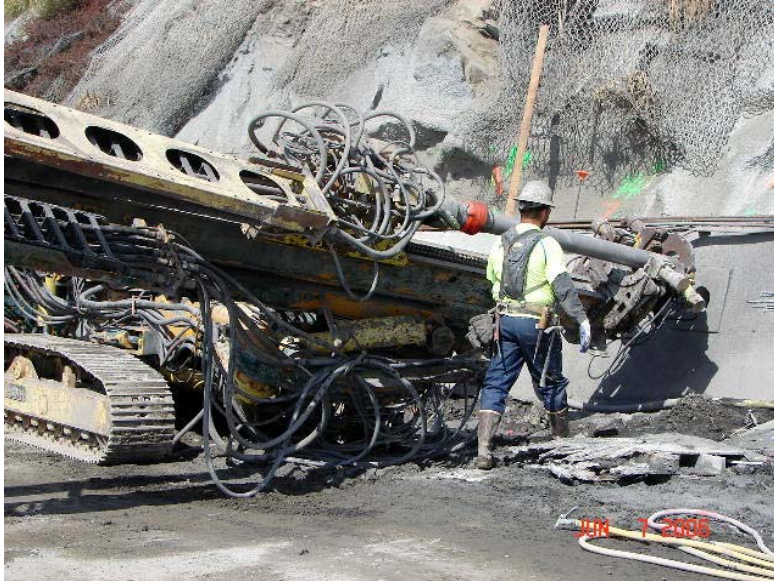
'Drill Tech' continued drilling for tie backs at the south end of wall 'C'. 5 out of 34 now complete.

Drilling at wall 'C' by day;

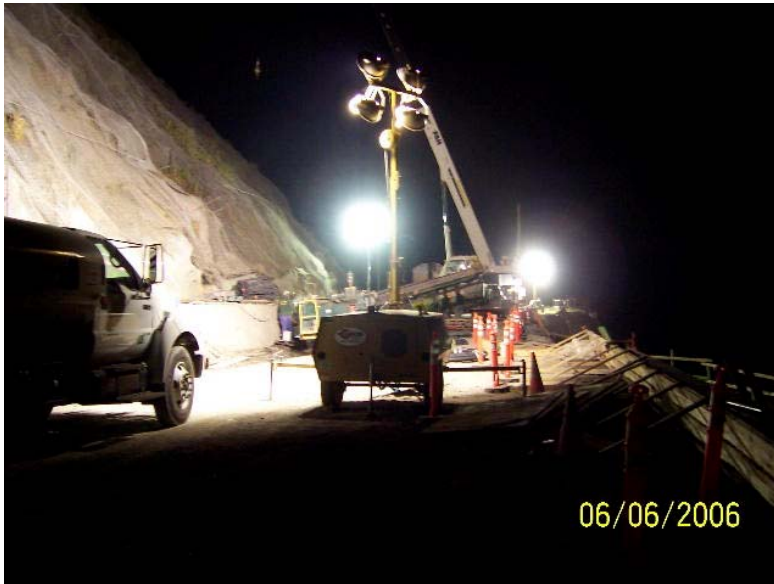
and night.
